Case Study 005:

WATERPROOFING EXISTING BUILDING - BAR M, CARDIFF

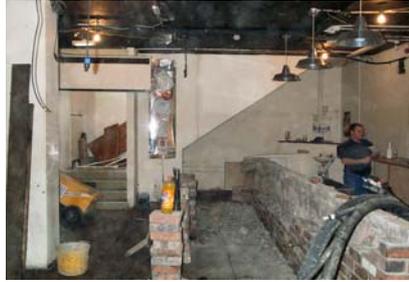
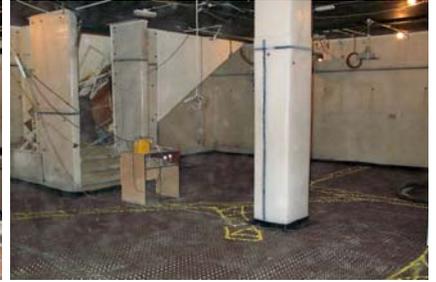
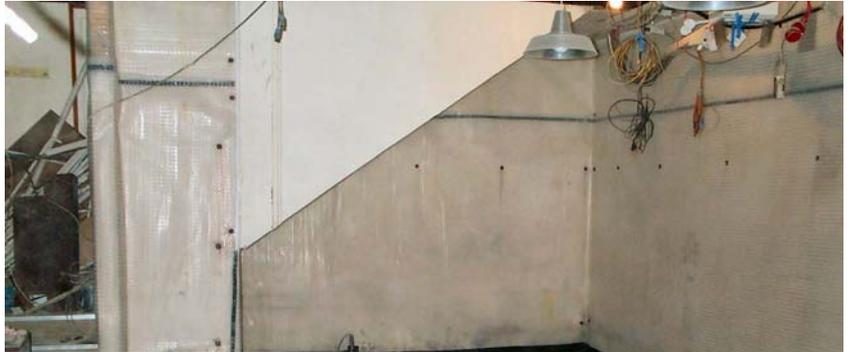
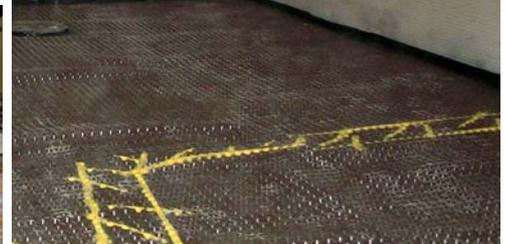
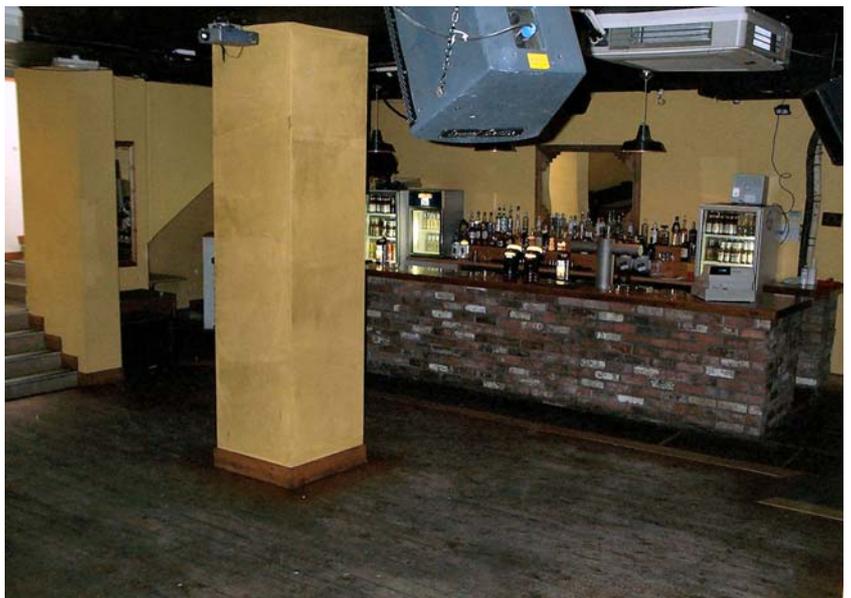
Protectahome designed and installed a Type C drained protection waterproofing system. The system included the use of drainage channels below the floor which are connected to multiple sump chambers containing automatic dual pumps, with high water alarms in each sump chamber.

The walls were lined to full height using an 8mm stud Cavity Drain Membrane. The membrane was "curtain hung" using 11mm Waterseal plugs with Butyl rubber seals.

The floor was lined with a 20mm stud Cavity Drain Membrane prior to being screeded and finishes being applied.

An independent metal stud wall containing the services was erected in front of the waterproofing and finished with plasterboard and skim plaster.
