Case Study 006:

## WATERPROOFING EXISTING BUILDING - VAULTS, ORCHARD ST, BRISTOL

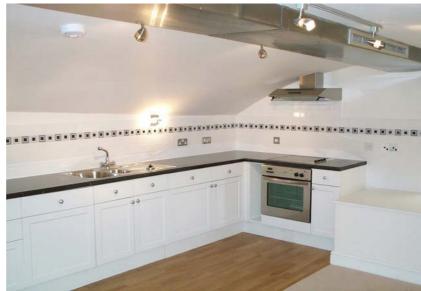
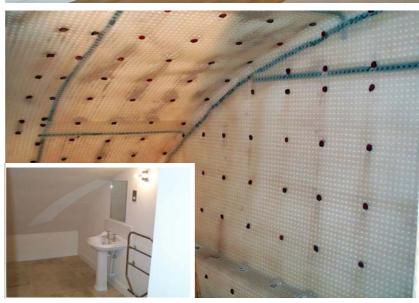
An unused Barrel Vaulted Basement beneath a listed town house scheduled for conversion into apartments.

The basement is fully below ground and subject to ground water ingress. The developer wanted to include the basement in the conversion allowing the ground floor flat to be sold as a maisonette, adding significant value to the development.

Protectahome designed and installed a Type C drained protection waterproofing system.

The walls and the barrel vaults were lined with an 8mm Meshed Cavity Drain Membrane, fixed ready to accept light weight plaster or direct bonded plaster board.

Perimeter drainage channels were installed linking back to a central Sump Chamber containing automatic Sump Pumps. The floors were sealed using a 3mm Cavity Drain Membrane and Waterseal tapes over closed cell insulation.
